Manhole Inspection Summary

Manhole # S31CC_037MH

Insp Date: **12/19/07 6:54 AM**

Location Address: **846 MLK JR BLVD**

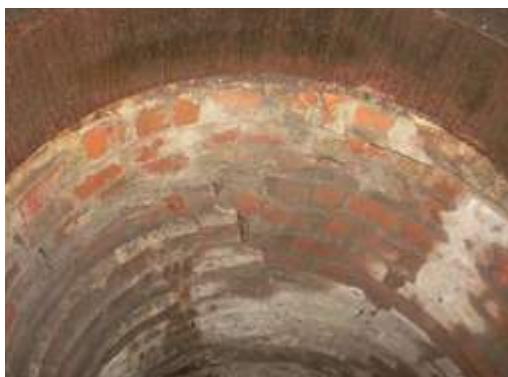
Defect 4

Condition: ☐ Sound ☒ **Cracked** ☐ Root Intrusion ☒ **Loose Brick** ☐ Deteriorated

MAJOR CORBEL CRACK

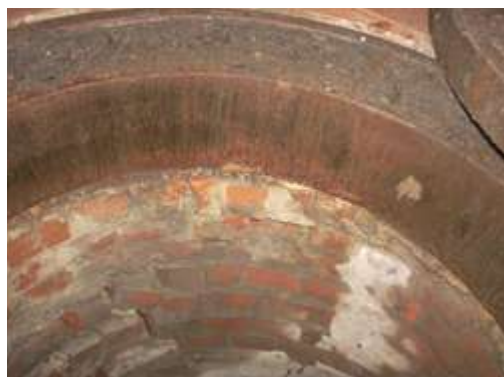
Defect 3

LOOSE CORBEL BRICKS

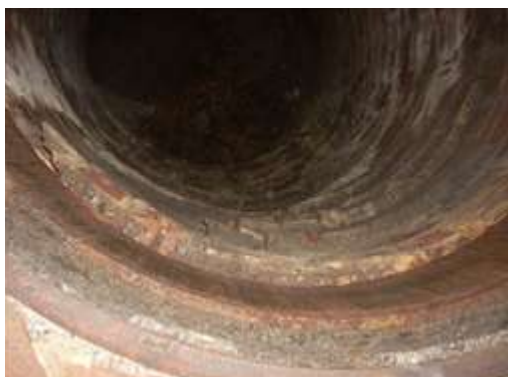
Defect 2

Frame Offset: **1** (in.) Condition: ☒ Sound ☐ Cracked ☐ Leaks

FRAME OFFSET

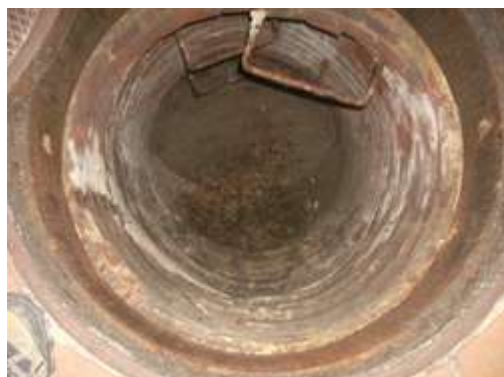
Defect 1

Steps Count: **6** Missing: **0** ☒ **Corroded**

CORRODED STEPS

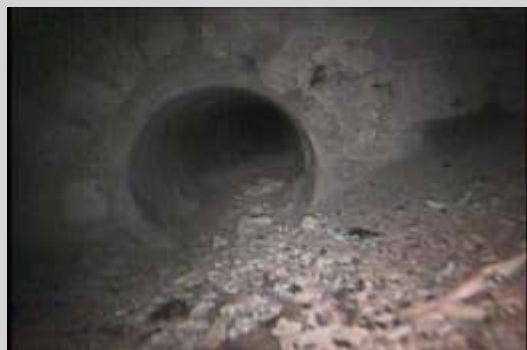
12 O'Clock Outflow

8 in. Circular Gravity Sewer
Pipe Out @ 12 O'Clock

Deposits: ☐ None ☐ Mud ☐ Sludge ☒ **Debris** ☐ Grease

Silt Depth: **1** (in.) Deposits Extent: **Light**
